Cause Investigation of Failure of the Challenge to World Record of Human-Powered Aircraft Flight: Operational Error and Disintegrating in Midair

ABSTRACT: Nihon University challenged world record of the human-powered aircraft flight based on the regulation of Fédération Aéronautique Internationale in Kasumigaura Lake, Japan, 2014. The wing fell off in midair immediately after take-off, the pilot landed to the lake for safety. So, the challenge failed. It guessed the operational errors were correlated with the wing falling in midair, which had not happened in our experience. The flight recording camera and the salvaged airplane were investigated. The fault tree analysis was conducted for cause investigation. The wing falling was the result as the chain destruction starting from the coupling parts being damaged in take-off. The defective take-off was caused by composite factors on only operational errors. The risk that the ultralight airplane might disintegrate in midair by only operational error became apparent.

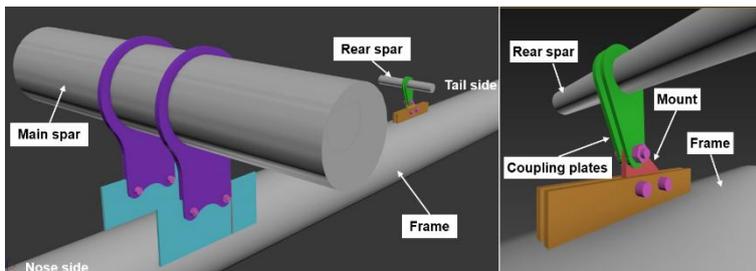
Fig. 2. Coupling section of the wing and the frame

The airplane is shown in Fig. 1 and Table 1. This airplane was the Daedalus type, whose main structures were made in CFRP and wings were formed by using Styrofoam. The airplane was able to disassemble into a wing, a frame including a cockpit, a propeller, a vertical tail and a horizontal tail. The wing was coupled with the frame by CFRP couplers and two stainless wire. The coupling section between the wing and the frame is illustrated in Fig. 2. The wing was bolted to the frame. Four bolts for front coupling and one bolt for rear coupling were used. At rear coupling, two coupling plates and a mount were coupled by one bolt and one nut. The vertical tail and the horizontal tail were movable, so each tail was also used respectively as a rudder and an elevator. A parking area near the Kasumigaura Lake and steel plates on the ground were used as a runway which is shown in Fig. 3. The whole distance of the runway was 105 m.

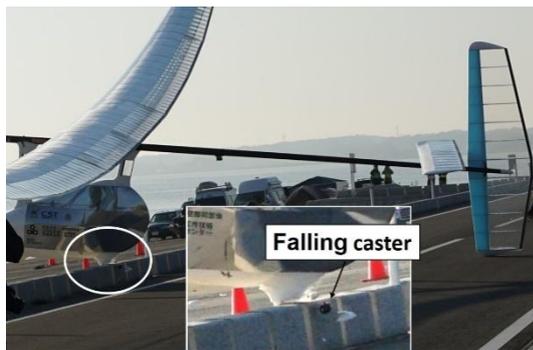
Fig. 5. The hitting on a curb stone

The description of the flight and the flight path are shown in Table 2 and Fig. 4, respectively. After assembly, the airplane started running in the condition of 1.6 m/s following wind. Although the airplane did not takeoff by the end of acceleration section which was 80 m point of the runway, cancellation orders did not be called. The airplane passed the end of acceleration section with excessive speed. The take-off became a forced take-off that the pilot steered the elevator to maximum angle. The flying height was not enough, so the caster at the bottom of the airplane and the bottom of the rudder hit on a curb stone placed on the extended line of the runway. The caster fell off and the rudder turned to the pitching direction by this hitting. These are shown in Fig. 5. The airplane flew to the gate which was the starting line of the challenge flight. The rudder and the elevator were able to steer normally. After a strange shock and a sound happened, the wing oscillated. The oscillation is illustrated in Fig. 6. The pilot heard some breaking sounds during flight. The amplitude of the oscillation increased gradually. The wing fell off at the distance of 550 m from the runway, then the pilot landed to the lake. The wing falling and landing to the lake are shown in Fig. 7.

(a) Falling caster

(b) Rudder turning

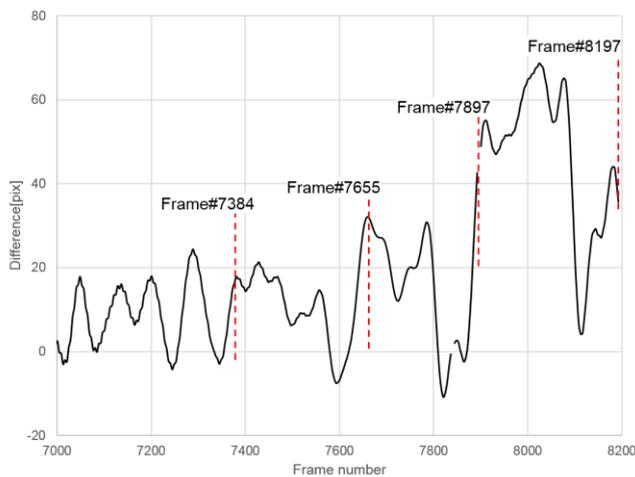
Fig. 9. Time evolution of the wing oscillation

The oscillation of the wing was obtained by using images of a camera installed into the frame. The camera frame rate was 29.97 fps. The positions of trailing edge of ribs nearest the frame and the axis of the frame, which are shown in Fig. 8, were obtained from camera images. The difference of the frame axis and the center of the wing was derived. The oscillation is shown in Fig. 9. The ordinate designates the difference in pixel of the frame axis and the center of the wing, the abscissa designates the frame number of the images. The ordinate value was processed by low-pass filter of threshold 6Hz. The positive value means that the center of the wing is at right side of the frame axis. From #7384 image, where a strange noise was heard from the video camera, the oscillation of the wing began to become strange. Since only the trailing edge turned, it guessed that the rear coupling section was broken. From #7655 image, where a big noise of crack formation was heard from the video camera, the amplitude of oscillation increased. It guessed that the rear coupling section was broken completely. From #7897 image, the amplitude of oscillation increased more and some damages, which is shown in Fig. 10, of the winglower surface at right side were recognized. At #8197 image, the wing fell off from the frame. Hence, the disintegration was separated into four phase.

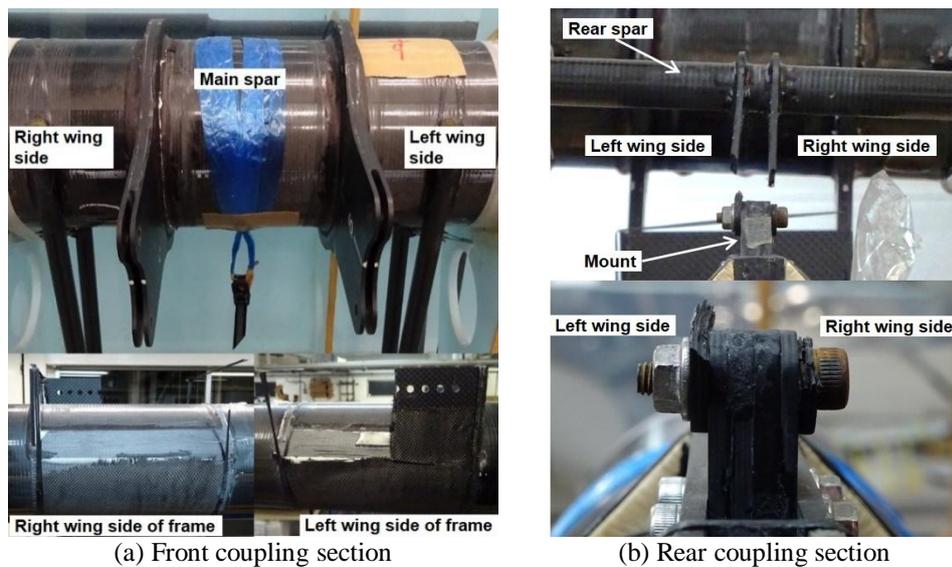
Fig. 11. The coupling section of salvaged airplane

The front and rear coupling section after salvage is shown in Fig. 11. The couplers of the main spar did not break. The coupler at right wing side of the frame fell off completely. The coupler at left wing side of the frame split from the center. Both rear coupling plates broke completely and each broke position was different. The position of the fracture surface at left wing side and right wing side was corresponding to the top of the mount and the bolt head, respectively. The cross section area of the fracture surface at the right wing side was less than the cross section area at the left wing side. The force for breaking the coupling plate at the right wing side is less than the one at left wing side, so the coupling plate at right wing side previously broke. Hence, the wing falling was a chain destruction which started from the breaking of the rear coupling plate at right wing side, then the rear coupling plate at left wing side, the front coupler at right wing side and the front coupler at left wing side broke subsequently. The sequence is illustrated in Fig. 12.

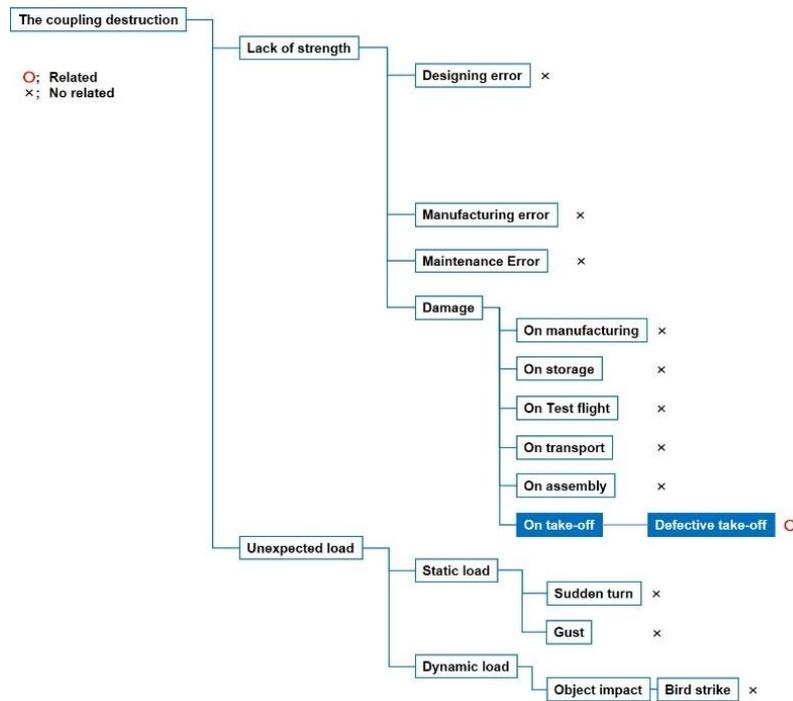
Fig. 13. Fault tree on the coupling destruction

The fault tree analysis was created on the destruction of the coupling of the wing and the frame as the top event. The fault tree is shown in Fig. 13. On designing, manufacturing and maintenance, there were no error. From the flight camera images and a weather monitor, an unexpected gust and a bird strike were not recognized. The airplane was inspected visually before assembly and was not damaged during assembly. So, the shock by hitting on a curb stone on defective take-off caused the coupling damage.

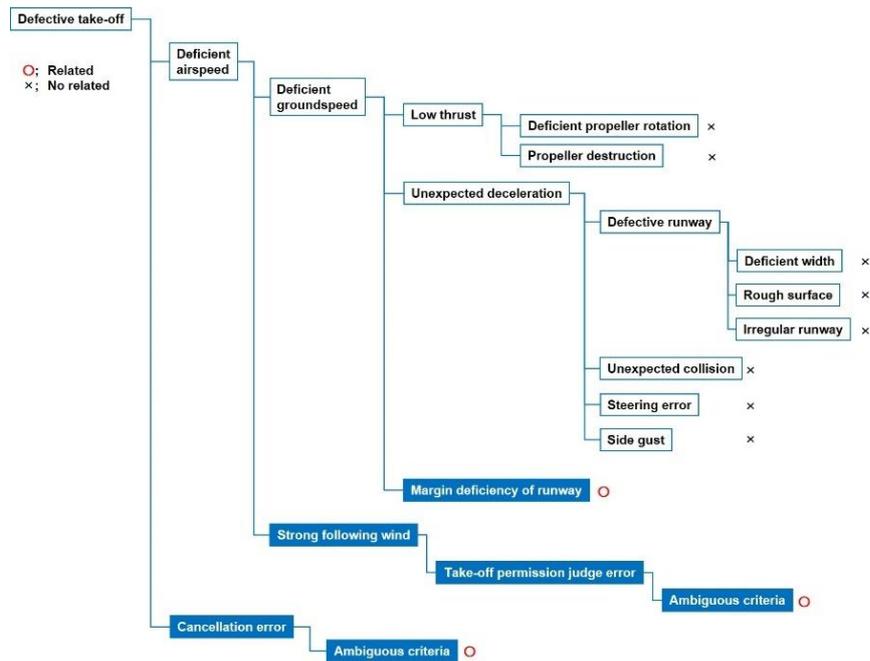
Fig. 14. Fault tree on defective take-off

The fault tree analysis was created on the defective take-off as the top event. The defective take-off was defined as cancellation orders did not be called though the airplane did not accelerate to the air speed enough to take-off in the runway. The fault tree is shown in Fig. 14. The pilot performance and the airplane ability were no related with the defective take-off. The runway and some operations were related with the defective take-off. The defective take-off was caused by composite factors which were margin deficiency of the runway distance, Go/NoGo judgment error for take-off permission and take-off cancellation judgment error during running. Hence, the take-off was permitted under weather condition exceeding the margin because judgment manual was not found though the runway distance margin was little. The suitable cancellation order was not able to be called because cancellation operating manual was not founded, then the take-off was forced.
