Cause Investigation of Failure of the Challenge to World Record of Human-Powered Aircraft Flight: Operational Error and Disintegrating in Midair

ABSTRACT: Nihon University challenged world record of the human-powered aircraft flight based on the regulation of Fédération Aéronautique Internationale in Kasumigaura Lake, Japan, 2014. The wing fell off in midair immediately after take-off, the pilot landed to the lake for safety. So, the challenge failed. It guessed the operational errors were correlated with the wing falling in midair, which had not happened in our experience. The flight recording camera and the salvaged airplane were investigated. The fault tree analysis was conducted for cause investigation. The wing falling was the result as the chain destruction starting from the coupling parts being damaged in take-off. The defective take-off was caused by composite factors on only operational errors. The risk that the ultralight airplane might disintegrate in midair by only operational error became apparent.

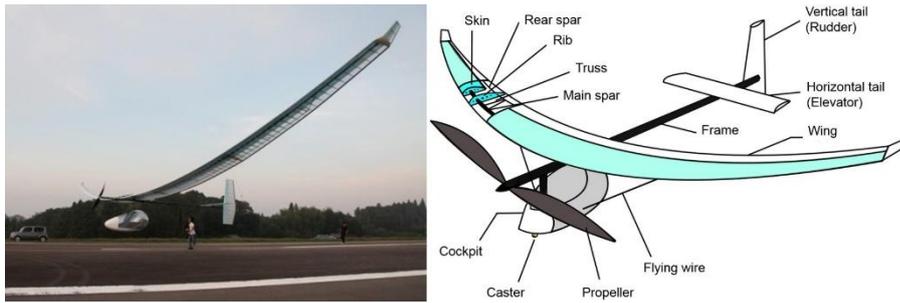
Fig. 1. The airplane

The airplane is shown in Fig. 1 and Table 1. This airplane was the Daedalus type, whose main structures were made in CFRP and wings were formed by using Styrofoam. The airplane was able to disassemble into a wing, a frame including a cockpit, a propeller, a vertical tail and a horizontal tail. The wing was coupled with the frame by CFRP couplers and two stainless wire. The coupling section between the wing and the frame is illustrated in Fig. 2. The wing was bolted to the frame. Four bolts for front coupling and one bolt for rear coupling were used. At rear coupling, two coupling plates and a mount were coupled by one bolt and one nut. The vertical tail and the horizontal tail were movable, so each tail was also used respectively as a rudder and an elevator. A parking area near the Kasumigaura Lake and steel plates on the ground were used as a runway which is shown in Fig. 3. The whole distance of the runway was 105 m.

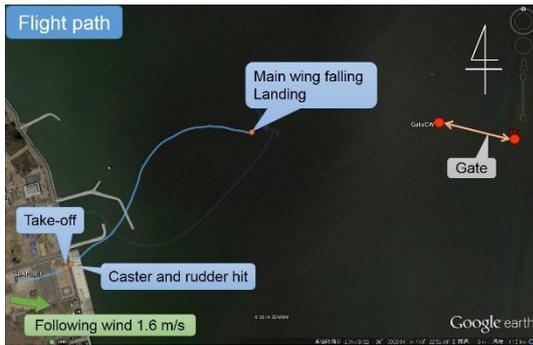
Fig. 4. Flight path

The description of the flight and the flight path are shown in Table 2 and Fig. 4, respectively. After assembly, the airplane started running in the condition of 1.6 m/s following wind. Although the airplane did not takeoff by the end of acceleration section which was 80 m point of the runway, cancellation orders did not be called. The airplane passed the end of acceleration section with excessive speed. The take-off became a forced take-off that the pilot steered the elevator to maximum angle. The flying height was not enough, so the caster at the bottom of the airplane and the bottom of the rudder hit on a curb stone placed on the extended line of the runway. The caster fell off and the rudder turned to the pitching direction by this hitting. These are shown in Fig. 5. The airplane flew to the gate which was the starting line of the challenge flight. The rudder and the elevator were able to steer normally. After a strange shock and a sound happened, the wing oscillated. The oscillation is illustrated in Fig. 6. The pilot heard some breaking sounds during flight. The amplitude of the oscillation increased gradually. The wing fell off at the distance of 550 m from the runway, then the pilot landed to the lake. The wing falling and landing to the lake are shown in Fig. 7.

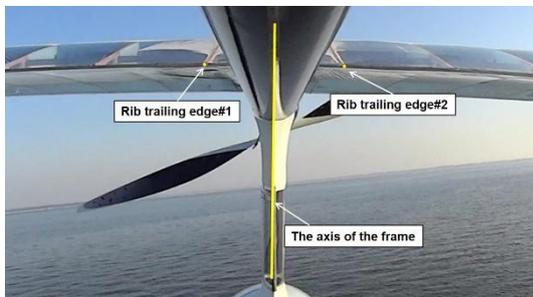
Fig. 8. Tracing point of rib trailing edge and the frame axis

The oscillation of the wing was obtained by using images of a camera installed into the frame. The camera frame rate was 29.97 fps. The positions of trailing edge of ribs nearest the frame and the axis of the frame, which are shown in Fig. 8, were obtained from camera images. The difference of the frame axis and the center of the wing was derived. The oscillation is shown in Fig. 9. The ordinate designates the difference in pixel of the frame axis and the center of the wing, the abscissa designates the frame number of the images. The ordinate value was processed by low-pass filter of threshold 6Hz. The positive value means that the center of the wing is at right side of the frame axis. From #7384 image, where a strange noise was heard from the video camera, the oscillation of the wing began to become strange. Since only the trailing edge turned, it guessed that the rear coupling section was broken. From #7655 image, where a big noise of crack formation was heard from the video camera, the amplitude of oscillation increased. It guessed that the rear coupling section was broken completely. From #7897 image, the amplitude of oscillation increased more and some damages, which is shown in Fig. 10, of the winglower surface at right side were recognized. At #8197 image, the wing fell off from the frame. Hence, the disintegration was separated into four phase.
